⑥ National Dam Inspection Program
Star Junction Number 1 Dam
(NDI Number PA-00198, PennDER
Number 26-30) Ohio River Basin,
Washington Run, Fayette County, Pennsylvania.

Phase I Inspection Report

STAR JUNCTION NO. 1 DAM
FAYETTE COUNTY, COMMONWEALTH OF PENNSYLVANIA
NDI NO. PA 00198
PennDER NO. 26-30

PHASE I INSPECTION REPORT
NATIONAL DAM INSPECTION PROGRAM

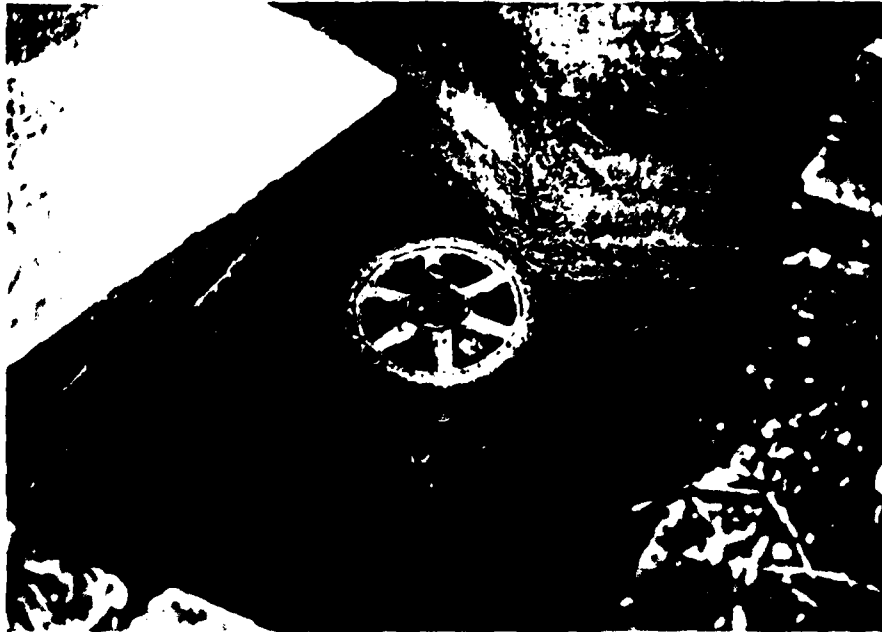
PHOTO 9. FLOODED GATE VALVE CONTROL CHAMBER,
NORTHWEST SIDE OF CHLORINATION HOUSE

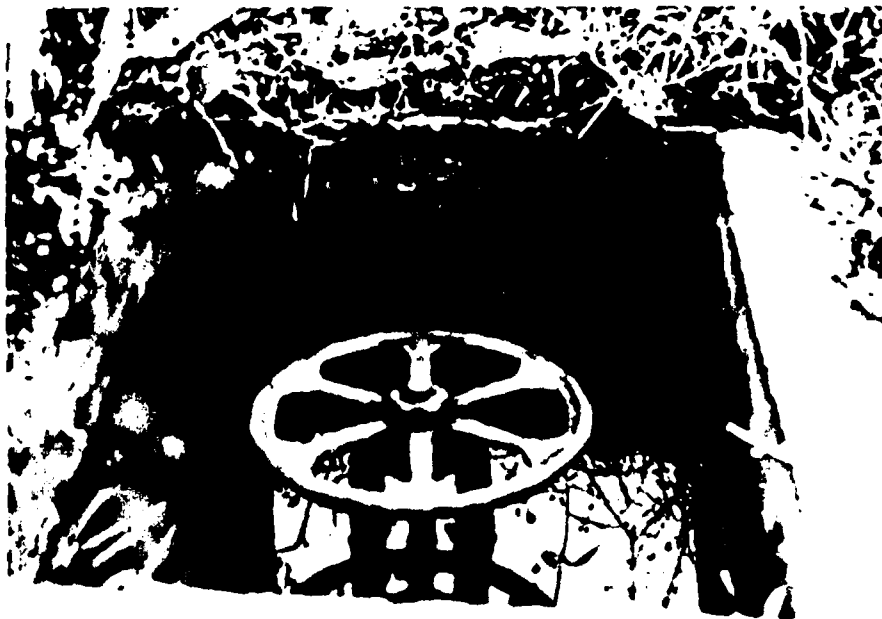
PHOTO 10. FLOODED GATE VALVE CONTROL CHAMBER BETWEEN
CHLORINATION HOUSE AND WATER STORAGE TANK
